## Attachment 1

### Unmaintained Road Corridors – Request for Service

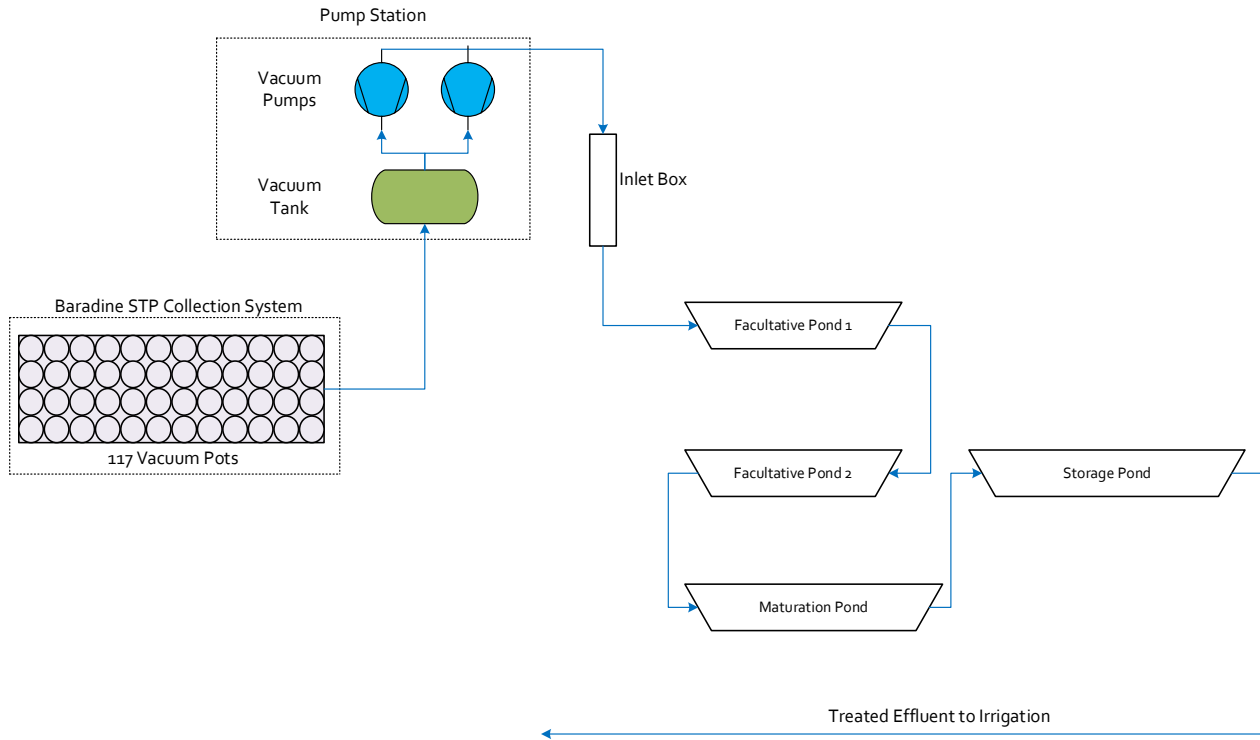
Figure 1-1: Baradine STP Process Flow Diagram

A process flow diagram showing the major processes at Baradine STP is presented in Figure 1-1.

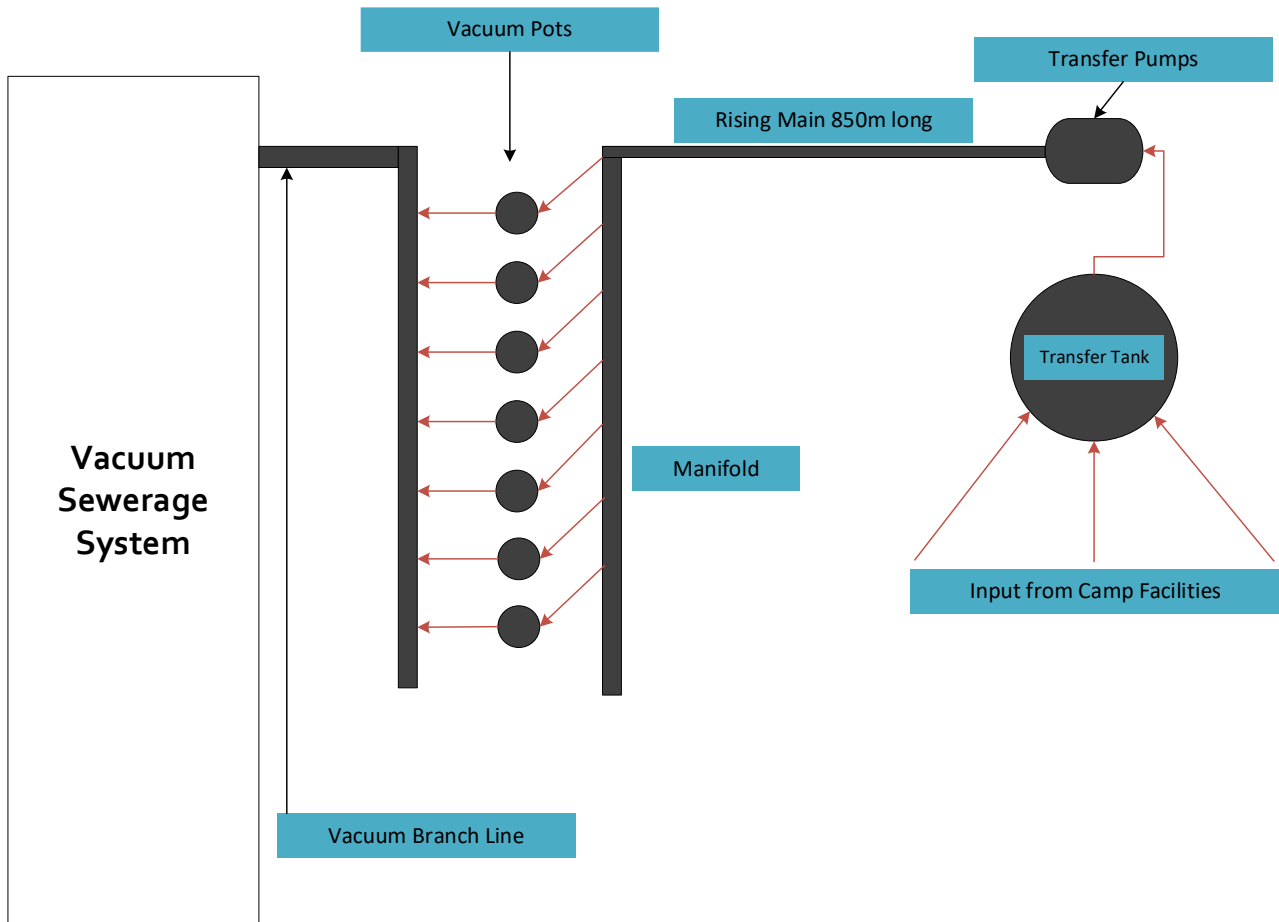
**Figure 3-1: Camp Cypress – Proposed Sewer Connection Layout**

Under this option, the Showground Trust would be required to provide all internal sewerage collection systems, including pumps, tanks and pipework.

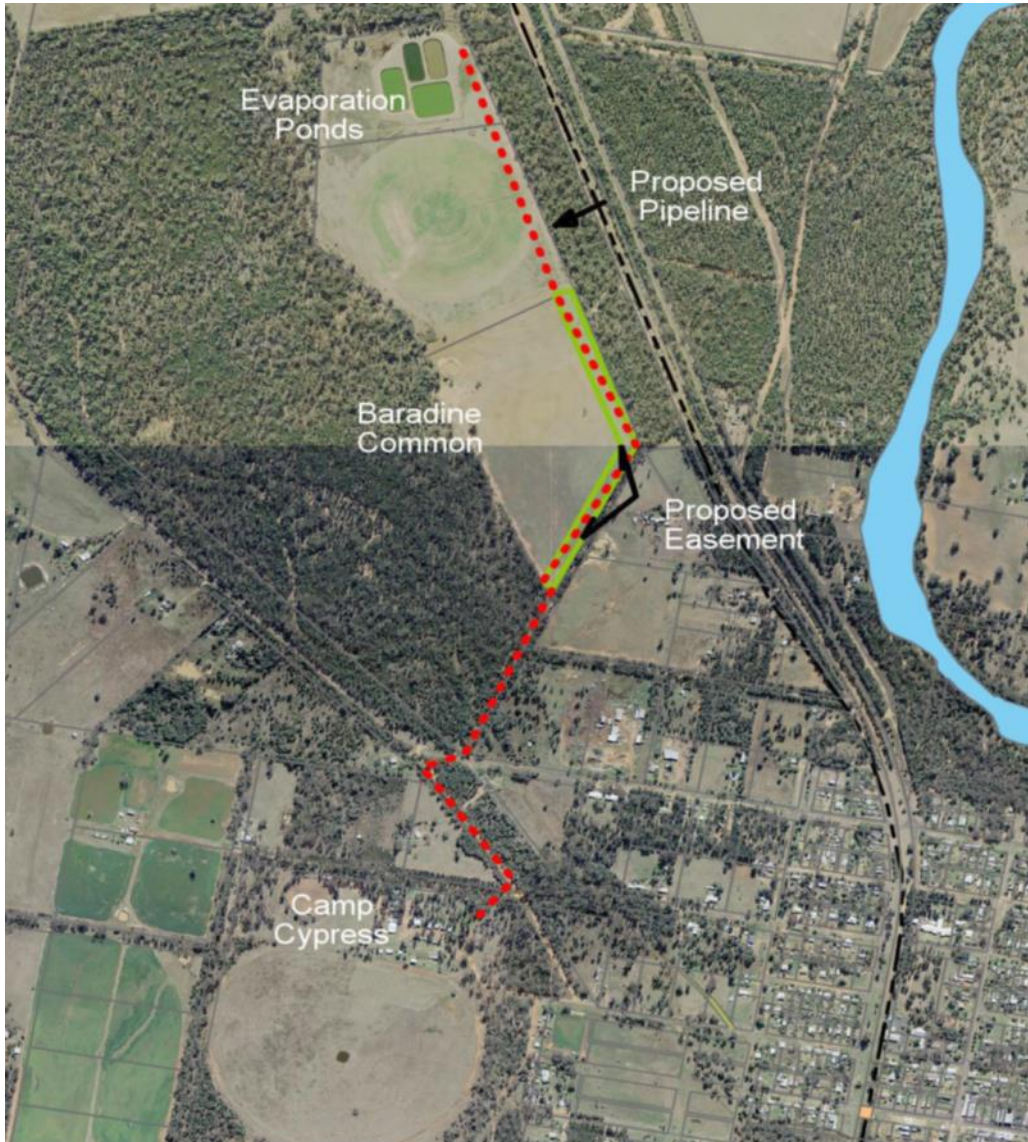
**Figure 3-2: Location of Proposed Sewer Pipeline Connecting Camp Cypress to the Baradine STP**

Figure 3-2 shows the location of the proposed sewer pipeline connecting Camp Cypress to the Baradine STP.

CWT is currently investigating typical and peak sewerage generation rates at the Camp and capacity of Baradine STP. This will determine the need to review connection options and update cost estimates.

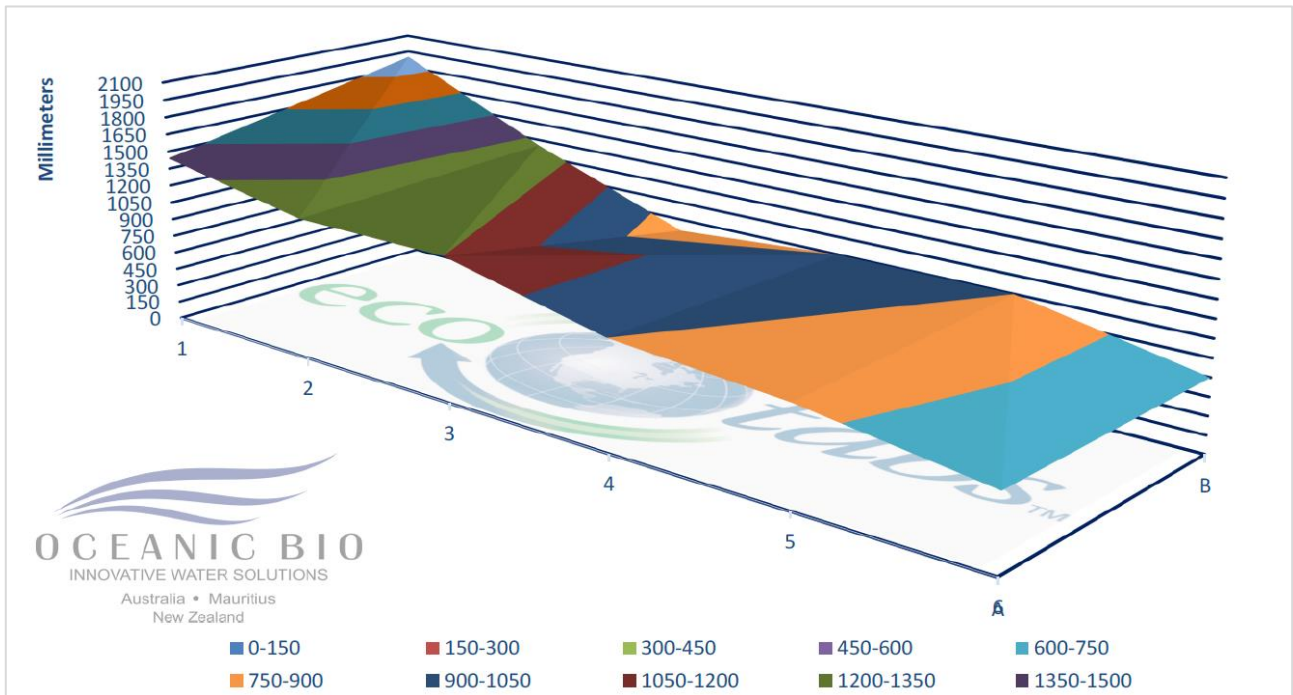
Figure 3-3: Baradine Sludge Survey 28 May 2014

In 2014, WSC commissioned Oceanic Bio Innovative Water Solutions to conduct a sludge survey at the Baradine Sewerage Ponds. The results obtained are presented below.

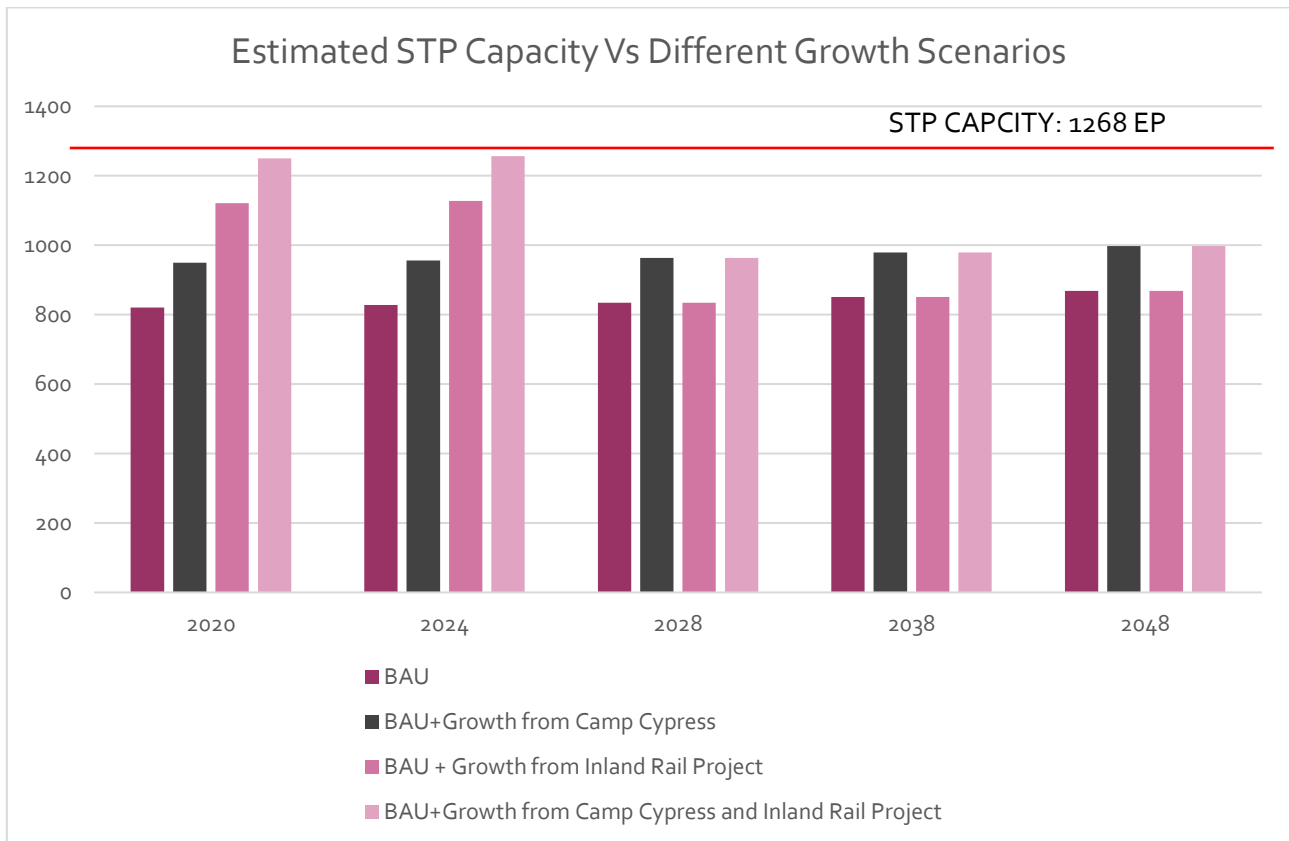
**Figure 4-1 Estimated STP Capacity Vs Different Growth Scenarios**

The Baradine STP has an assessed treatment capacity of 1268 EP (See Appendix C for Capacity Assessment Calculation). Assessment uses the mean temperature of the air in the coldest month. Higher temperatures will improve the STP’s capacity to handle the higher organic loadings.

Following Figure 4-1 indicated that the STP has enough capacity to treat the wastewater from Baradine under different growth scenarios until 2048.

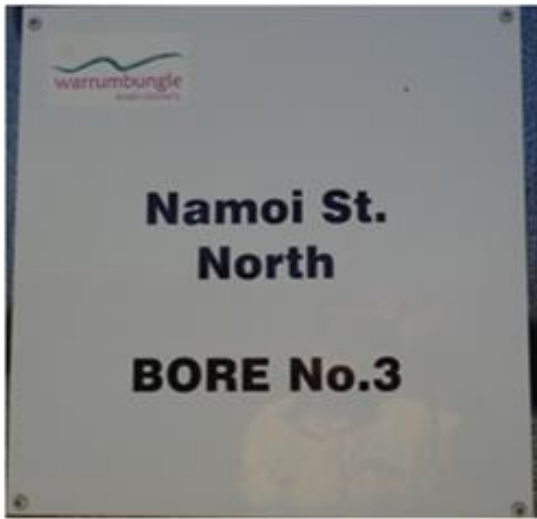
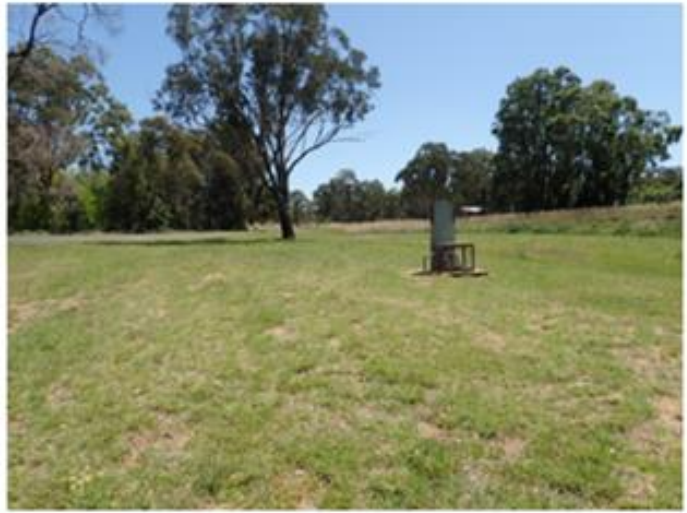
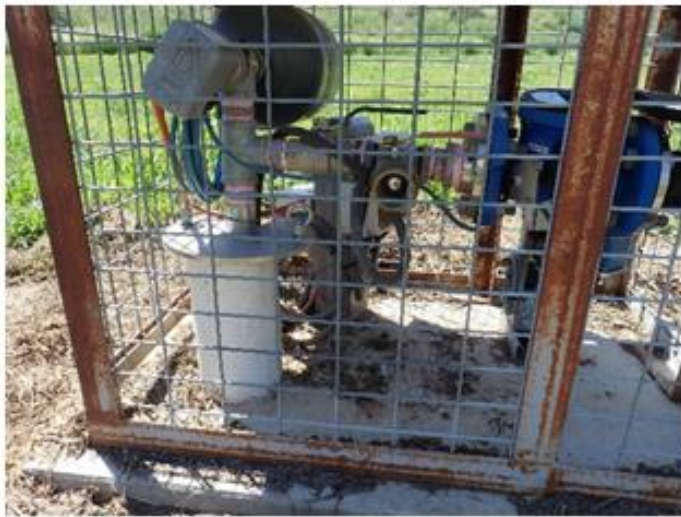
**Figure 3: Coonabarabran Namoi St North Bore 3**

<b>GPS Coordinates</b>	Latitude: -31.26889100 Longitude: 149.27073800
<b>Date of Inspection</b>	14/10/2020
<b>Original Form A or Drill log or Bore Sketch</b>	NA
<b>Pump-test data available. Stage and constant test</b>	NA
<b>Water Quality Data</b>	Checked annually
<b>Camera or previous geophysical investigations</b>	NA
<b>Any maintenance issues in the past</b>	NA
<b>Any records of pumping sand or turbid water</b>	NA
<b>Any monitoring program, maintenance checks, frequency</b>	PVC Casing
<b>Any records of pumping problems</b>	NA
<b>Type of pump</b>	NA
<b>Pump depth setting</b>	NA
<b>Type of pump column and diameter</b>	NA
<b>Cleanliness of pump column when pulled. Any red or brown ochre colour?</b>	NA
<b>Details of pump and pump column diameter fittings</b>	NA
<b>Any signs of pumping sand from bore</b>	NA
<b>Any examples of old pump column left near the bore indicating possible iron or corrosion issues with pump column</b>	NA

<b>Estimate of specific capacity of the well. Flow rate vs drawdown</b>	NA
<b>Site details including accessibility</b>	NA
<b>Additional comments</b>

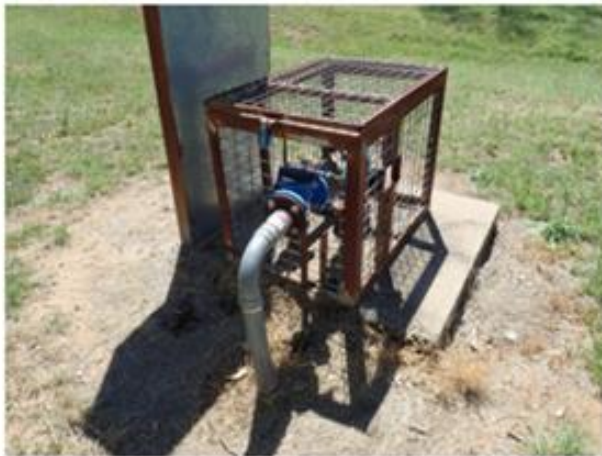
**Figure 4 - Coonabarabran Namoi St North Bore 4**

**Bore 4 – Namoi St North** This bore is located further north on Namoi Street on Lot 1, DP 1085566 Coonabarabran. This bore does not yield much water and pumps a small amount of sand. Due to this it is used as a backup water supply.

<b>Any examples of old pump column left near the bore indicating possible iron or corrosion issues with pump column</b>	NA
<b>Estimate of specific capacity of the well. Flow rate vs drawdown</b>	NA
<b>Site details including accessibility</b>	Power is underground
<b>Additional comments</b>

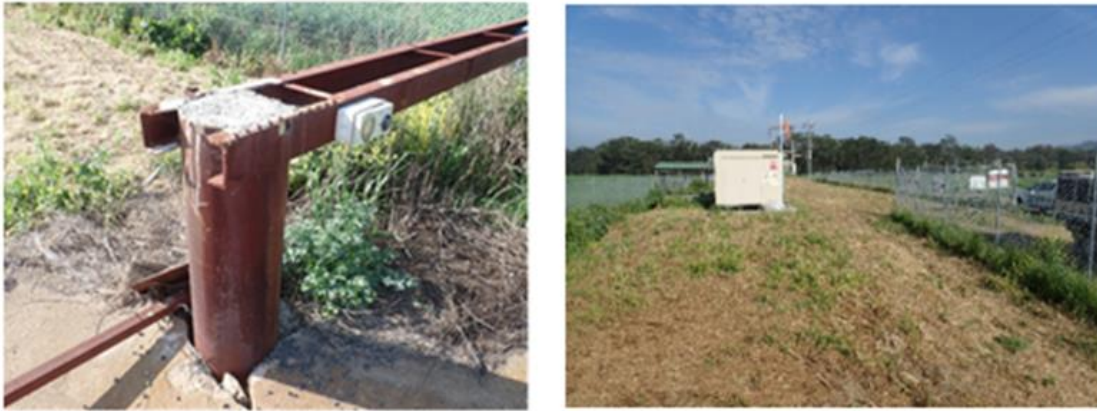
**Figure 6 - Coolah Old Bore**

<b>GPS Coordinates</b>	Latitude: -31.81175000 Longitude: 149.74324000
<b>Date of Inspection</b>	07/10/2020
<b>Original Form A or Drill log or Bore Sketch</b>	Capped / decommissioned
<b>Pump-test data available. Stage and constant test</b>	NA
<b>Water Quality Data</b>	NA
<b>Camera or previous geophysical investigations</b>	NA
<b>Any maintenance issues in the past</b>	NA
<b>Any records of pumping sand or turbid water</b>	NA
<b>Any monitoring program, maintenance checks, frequency</b>	NA
<b>Any records of pumping problems</b>	NA
<b>Type of pump</b>	NA
<b>Pump depth setting</b>	NA
<b>Type of pump column and diameter</b>	300mm (12")
<b>Cleanliness of pump column when pulled. Any red or brown ochre colour?</b>	NA
<b>Details of pump and pump column diameter fittings</b>	NA
<b>Any signs of pumping sand from bore</b>	NA
<b>Any examples of old pump column left near the bore indicating possible iron or corrosion issues with pump column</b>	NA

<b>Estimate of specific capacity of the well. Flow rate vs drawdown</b>	NA
<b>Site details including accessibility</b>	Good accessibility to site. No overhead powerlines
<b>Additional comments</b>

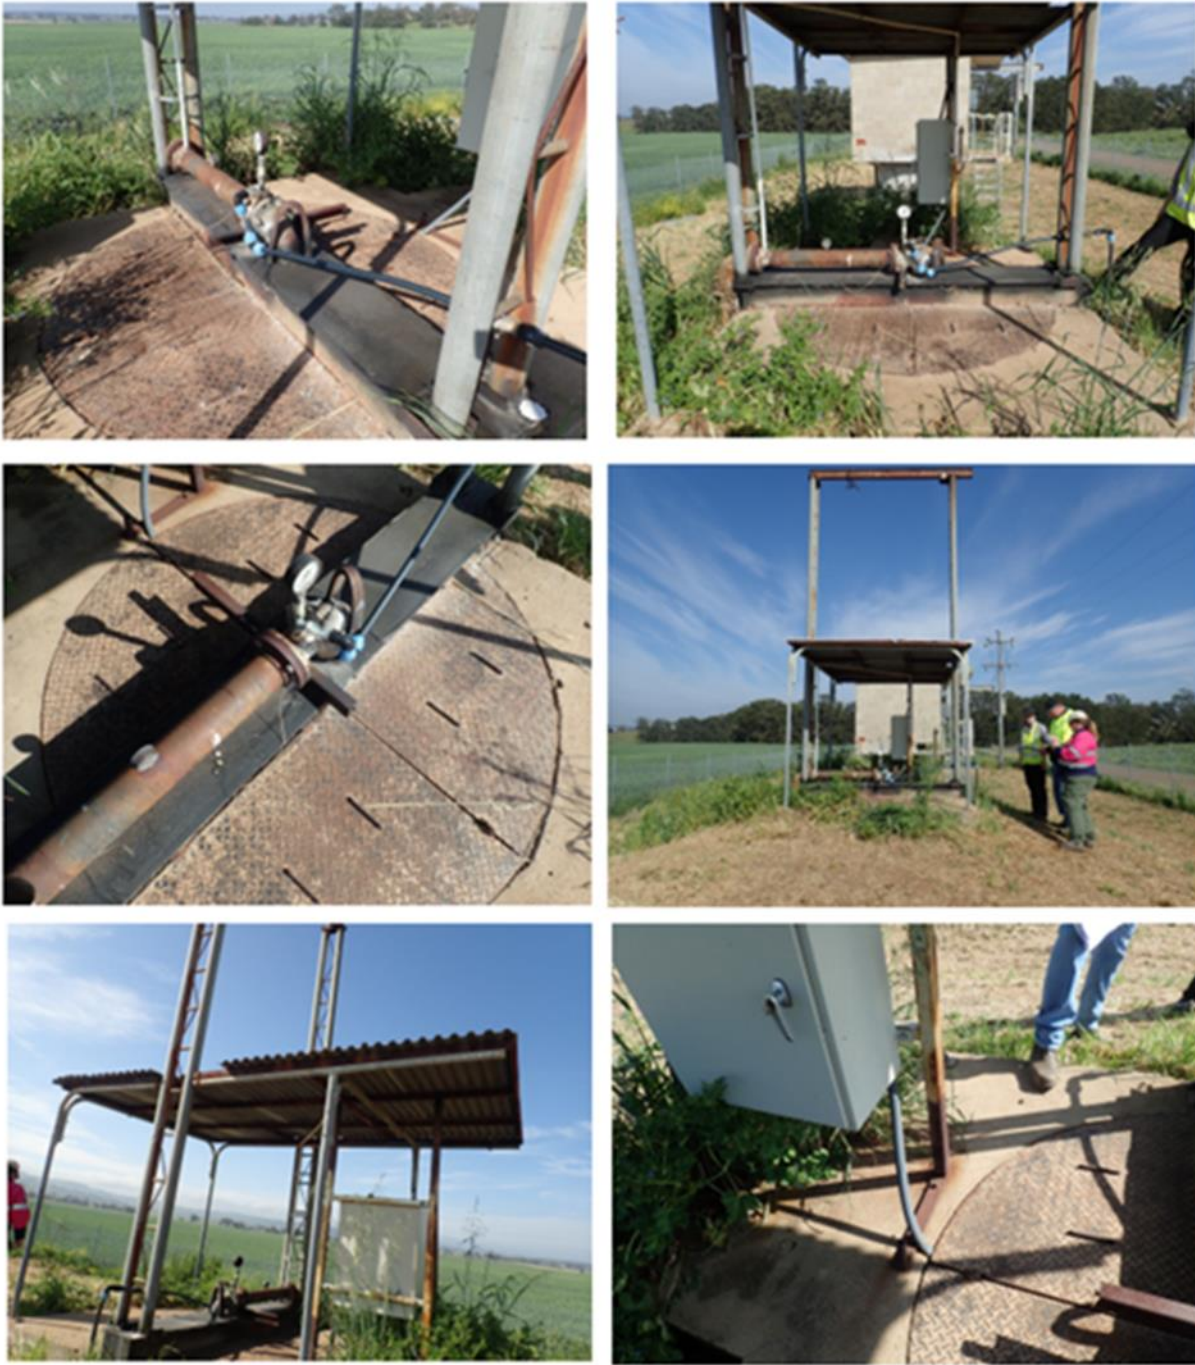
**Figure 7 - Coolah Back -up Well**

<b>Estimate of specific capacity of the well. Flow rate vs drawdown</b>	NA
<b>Site details including accessibility</b>	5 m water table
<b>Additional comments</b>	9 m to sandstone

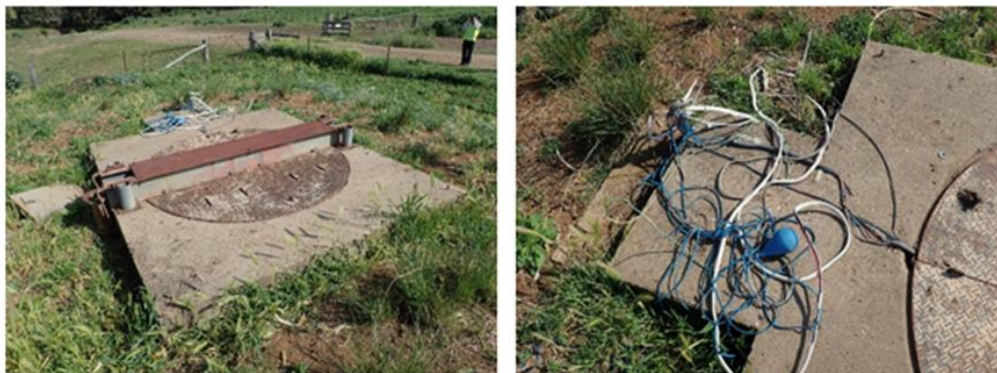
**Figure 8 - Coolah Extra Well**

<b>GPS Coordinates</b>	Latitude: -31.81157500 Longitude: 149.74199800
<b>Date of Inspection</b>	07/10/2020
<b>Original Form A or Drill log or Bore Sketch</b>	NA
<b>Pump-test data available. Stage and constant test</b>	NA
<b>Water Quality Data</b>	NA
<b>Camera or previous geophysical investigations</b>	NA
<b>Any maintenance issues in the past</b>	NA
<b>Any records of pumping sand or turbid water</b>	NA
<b>Any monitoring program, maintenance checks, frequency</b>	NA
<b>Any records of pumping problems</b>	NA
<b>Type of pump</b>	NA
<b>Pump depth setting</b>	NA
<b>Type of pump column and diameter</b>	NA
<b>Cleanliness of pump column when pulled. Any red or brown ochre colour?</b>	NA
<b>Details of pump and pump column diameter fittings</b>	NA
<b>Any signs of pumping sand from bore</b>	NA
<b>Any examples of old pump column left near the bore indicating possible iron or corrosion issues with pump column</b>	NA
<b>Estimate of specific capacity of the well. Flow rate vs drawdown</b>	NA

<b>Site details including accessibility</b>	NA
<b>Additional comments</b>	6 ft hole/well

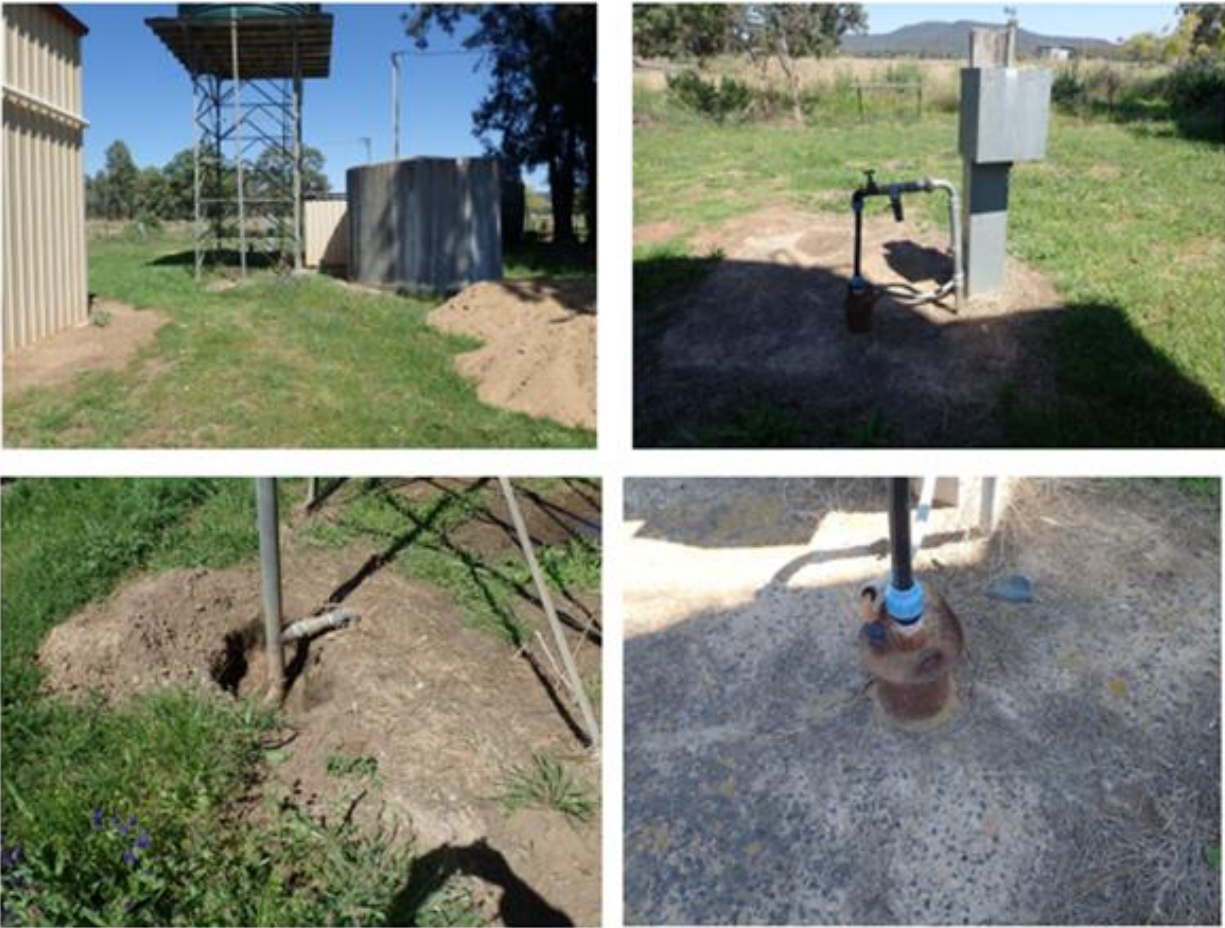
**Figure 12 - Bugaldie Bore**

<b>Any signs of pumping sand from bore</b>	NA
<b>Any examples of old pump column left near the bore indicating possible iron or corrosion issues with pump column</b>	NA
<b>Estimate of specific capacity of the well. Flow rate vs drawdown</b>	NA
<b>Site details including accessibility</b>	NA
<b>Additional comments</b>

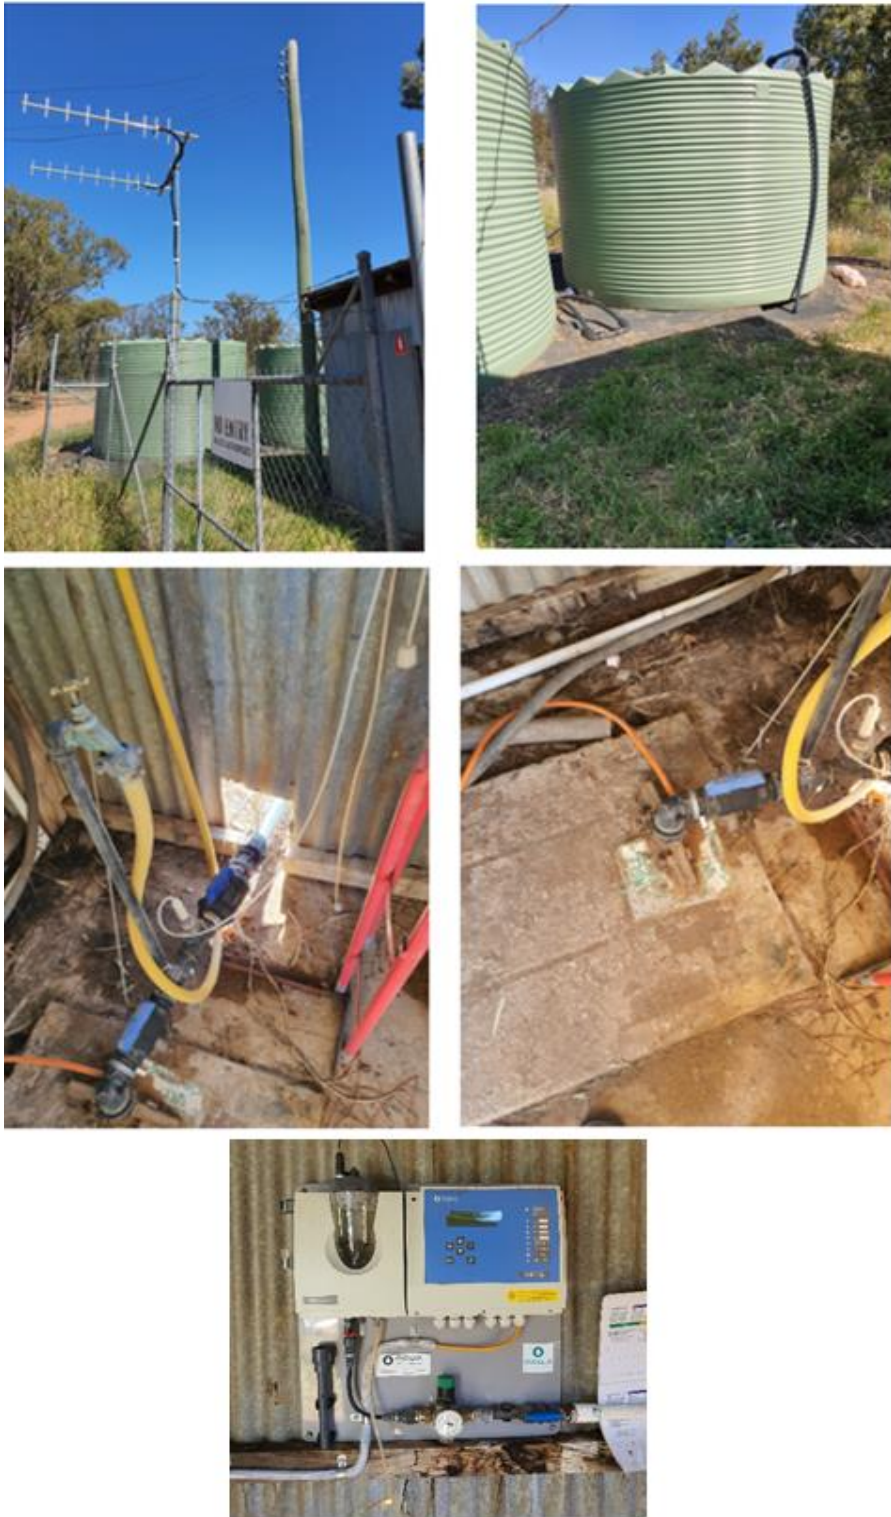
**Figure 13 - Kenebri Bore**

<b>Condition of casing, well cap and slab</b>	Low risk, no obvious surface problems
<b>Well age</b>	71 years, high risk
<b>Well type</b>	Low/moderate risk
<b>Screen type</b>	Assume slotted casing and open hole bottom, 4 m
<b>Bore material</b>	Mild steel, moderate/high risk
<b>Pump depth setting</b>	No record
<b>Bore cementing</b>	No
<b>Gravel pack or natural pack</b>	Sedimentary rock
<b>Water quality</b>	Some comments on iron and sand, no data recorded
<b>Iron level</b>	No record
<b>Salinity level</b>	No record
<b>Relationship of pump depth setting and screen level to iron hydroxide potential</b>	No record
<b>Comments</b>	This bore has had some sand problems in the past
<b>Conclusion</b>	High risk
