Report on the Baradine Heritage Main Street Study

February 2014

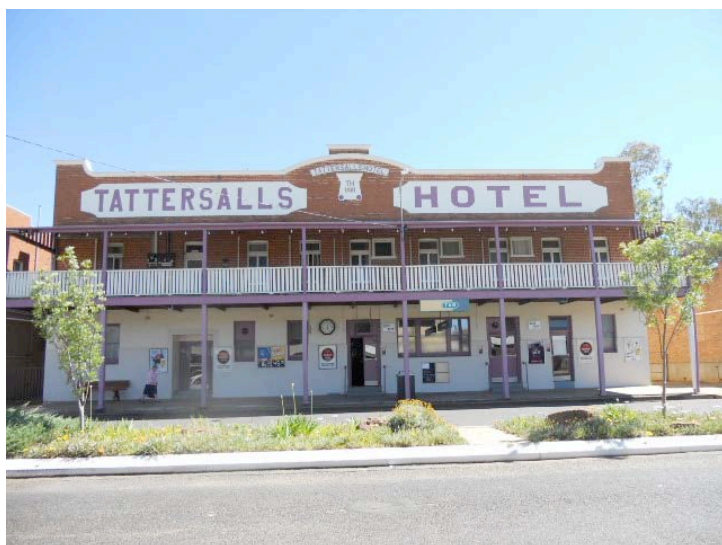
Plate 3.1: Tattersalls Hotel, a prominent Edwardian era building.

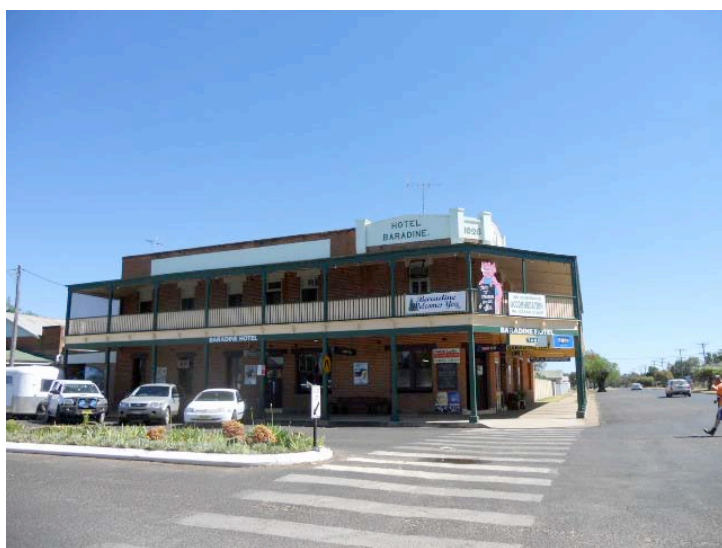
Plates 3.2 & 3.3:
Prominent Inter-War
buildings – Hotel
Baradine (left) &
Kosciusko Cafe (right).

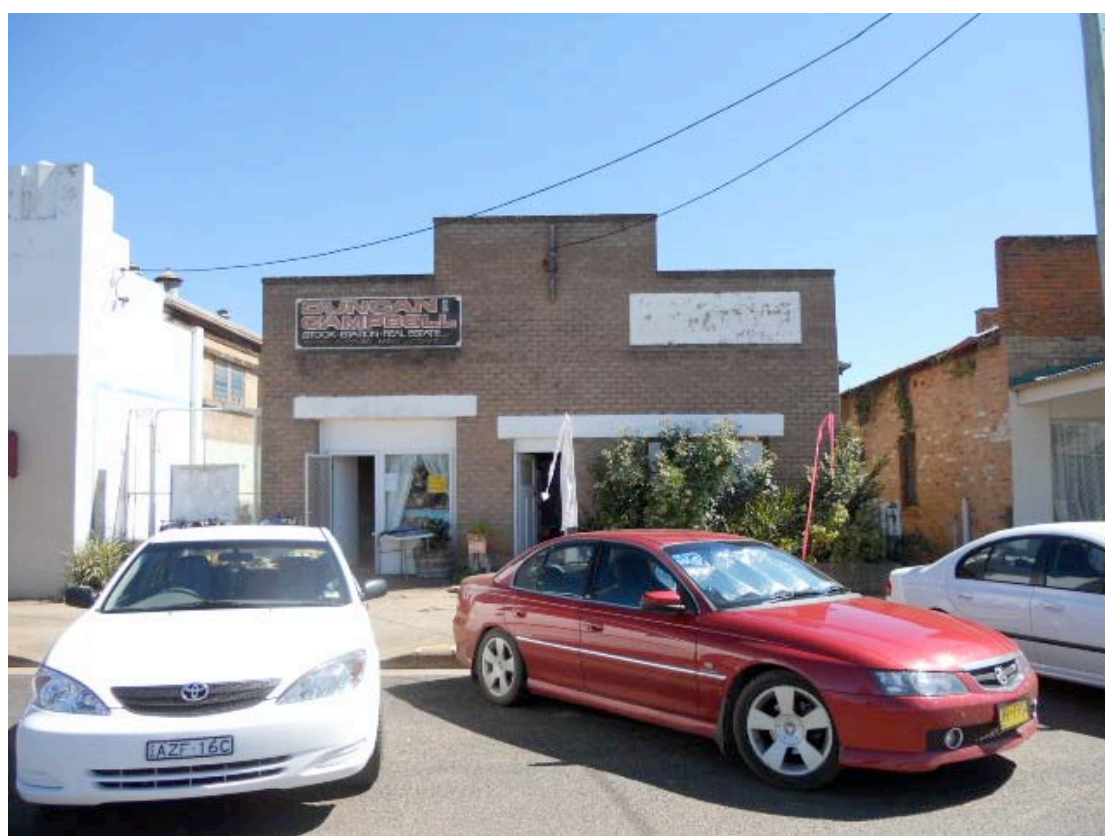
Plate 3.4: Former Duncan Campbell building.

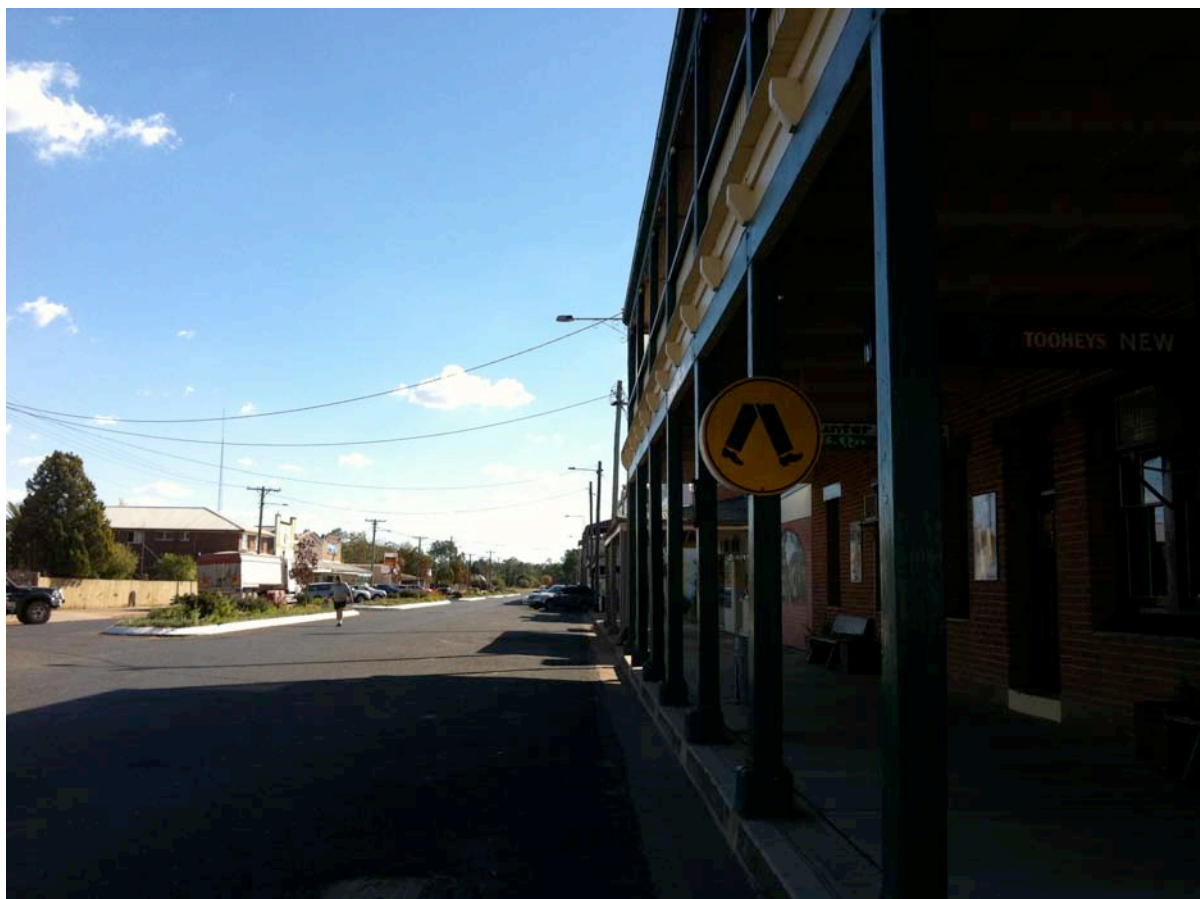
Plate 5.1: Verandahs help to define the character of Wellington Street.

A number of these awnings appear to be in need of repair. A formal assessment of the structural integrity of all awnings should be undertaken by a certified structural engineer.

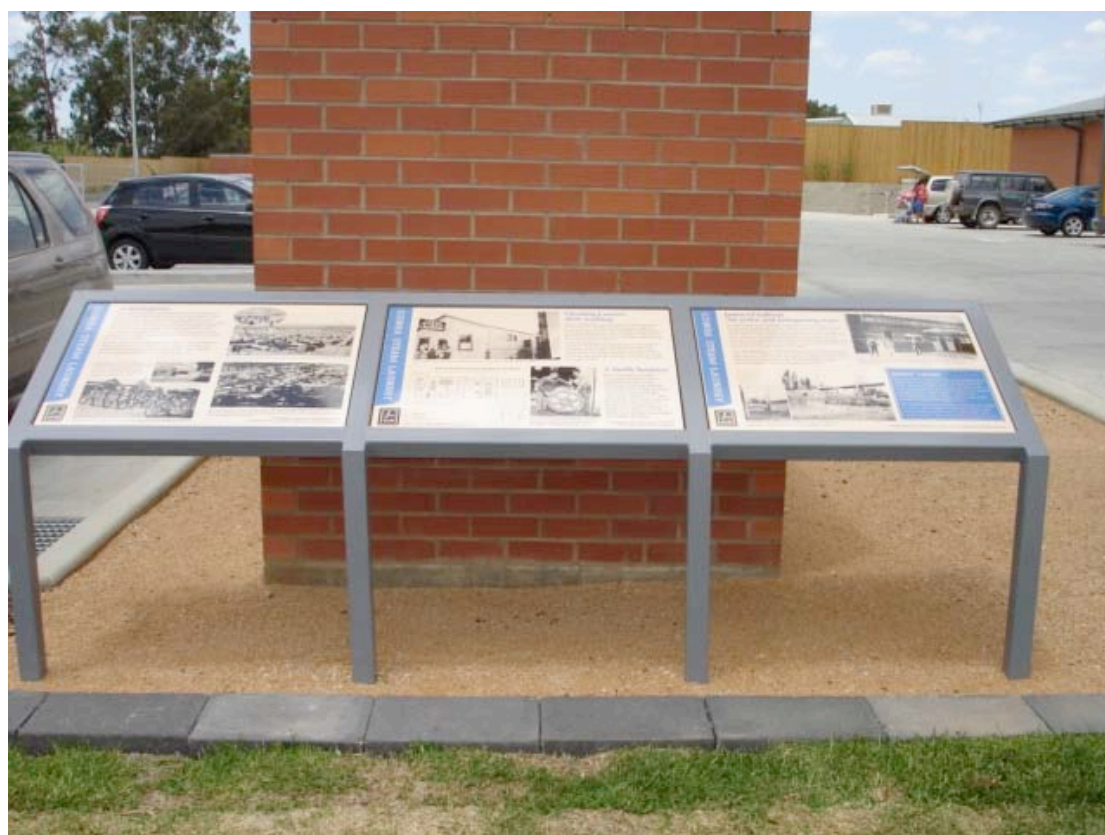
Plate 8.1: Interpretive signage incorporated into the Cowra ALDI development tells the story of the steam laundry formerly located on the site, and the family who operated it. These interpretations, required as part of the development approval, were planned to integrate with the ALDI corporate colours and feature the ALDI logo.

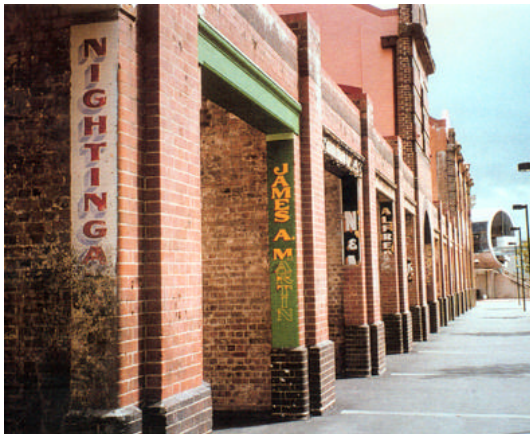
Before conservation works to the market signs in Quay Street, Haymarket, 1996.

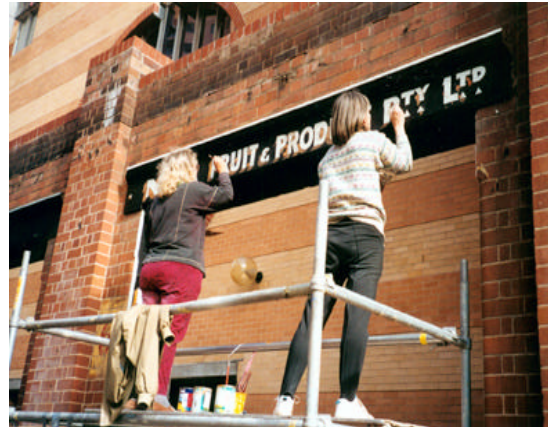
During conservation works to the market signs in Quay Street, Haymarket, 1999.

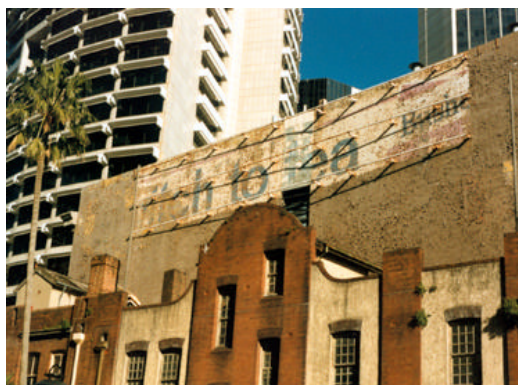
‘Switch to tea’ sign on the northern facade of the Bushells Building before conservation, 1999.

As the 1991 Conservation Plan for the building recommended the conservation of the sign, the building authorities, the Sydney Harbour Foreshore Authority, encouraged and gave approval for the project. The adaptive reuse project of the Bushell’s Building received a UNESCO ASIA-Pacific Award in 2001 and the conserved Bushells sign on the northern facade is a predominant image of the publicity photographs.

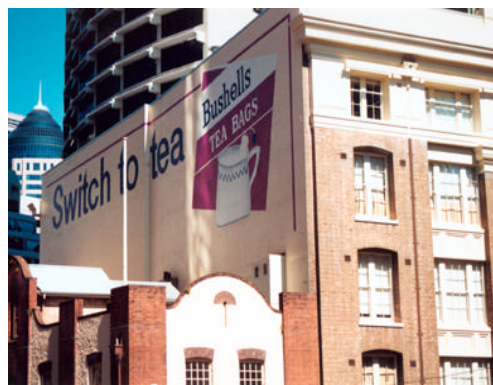
The sign following conservation, 2001.

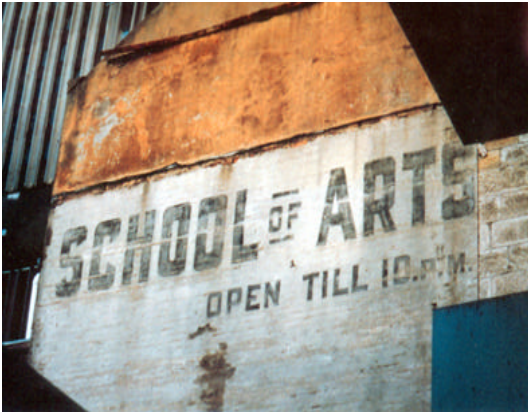
The "School of Arts" sign before conservation, 1998.

The sign on the former School of Arts Building in Pitt Street, Sydney, which advertised its opening hours, was considered to be an important aspect of the social significance of the building. The heritage architect undertaking the School of Arts conservation project engaged a sign writer to undertake the conservation, as the sign was fairly simple in its design, despite its importance and association with the building. The sign was conserved following approach A, and required very little infill or reconstruction of missing paint to allow the sign to be revitalised.

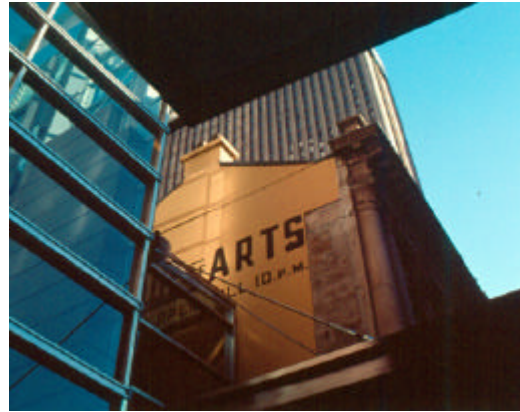
The sign following conservation, 2000.
